Manhole Inspection Summary

Manhole # S25M__006MH

Location Address: **1272 Sargeant St**

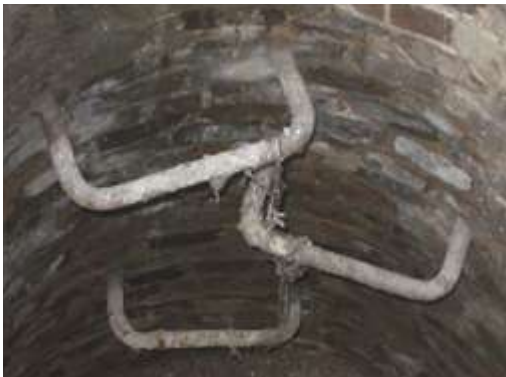
Defect 4

Surcharge ☒ **Evidence Of Surcharge** Depth: **3** (ft.) ☐ Active Surcharge Present

corroded rungs and signs of surcharge

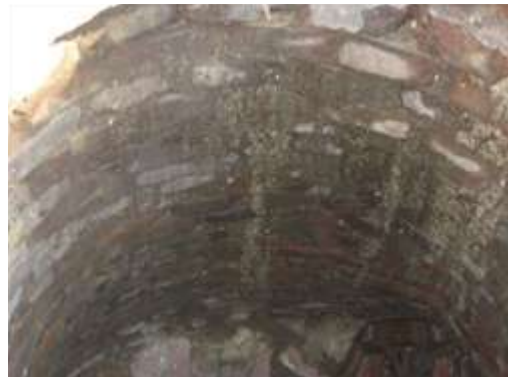
Defect 3

Infiltration: ☐ None ☐ Joint ☐ Cracks ☐ Mortar ☐ Roots ☒ **Wall**

sign of infiltration in corbel and barrel walls

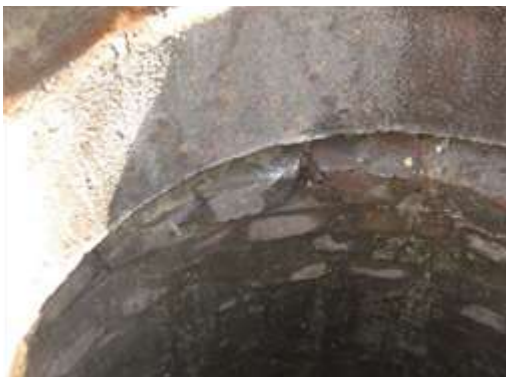
Defect 2

Infiltration: ☐ None ☒ **Joint** ☐ Cracks ☐ Mortar ☐ Roots ☒ **Wall**

signs of infiltration at chimney joint & wall

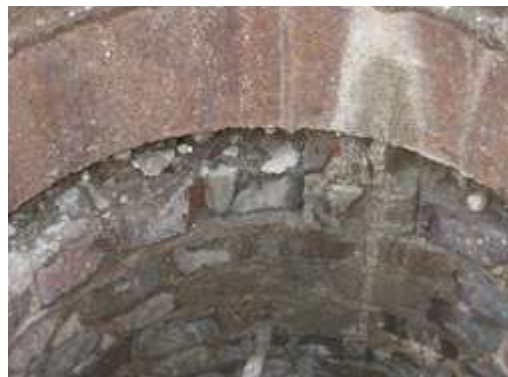
Defect 1

Condition: ☐ Sound ☐ Cracked ☐ Root Intrusion ☒ **Loose Brick** ☒ **Deteriorated**

chimney loose/missing bricks, deteriorated
